Troll Solution Case Study – Wreck Removal

Troll Solution – Accident 5 May 2015

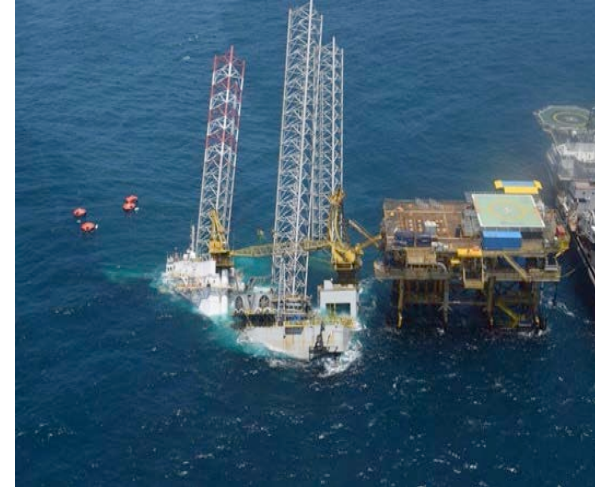
- 100 persons onboard
- During elevation, the unit suffered leaning instability for stbd. leg.
- 10° list, increasing to 14°.
- Unit evacuated.
- Problems with lifeboat launching – on-load release mechanism released.
- 2 persons deceased, several injured.
- Bow leg later collapsed, resulting in a list of 35° and trim of 15°. Unit resting on port leg and on the sea floor at bow and starboard side.
- Media handling required.

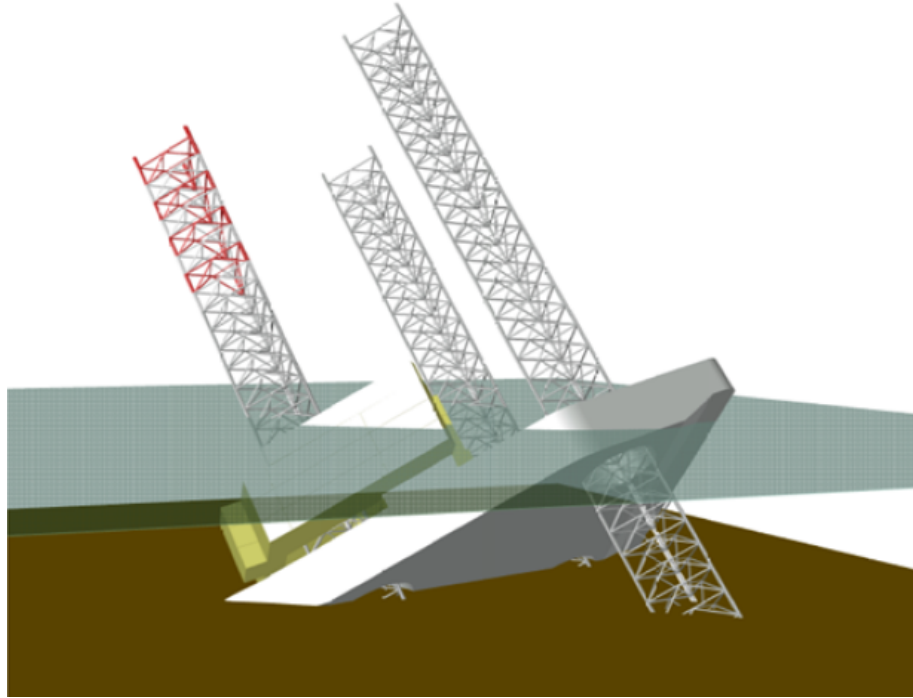
Port side view

After collapsing of bow leg and stbd. leg.

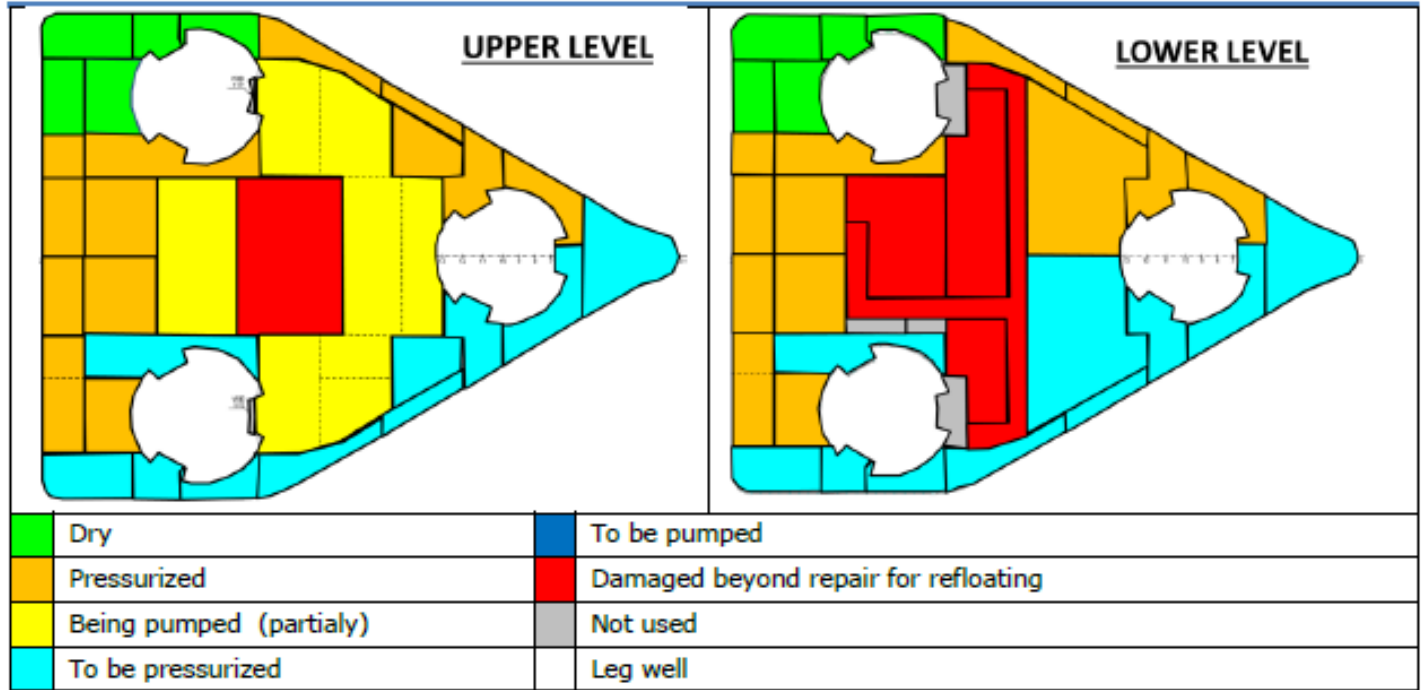
Troll Solution - Sunk 26 October 2015

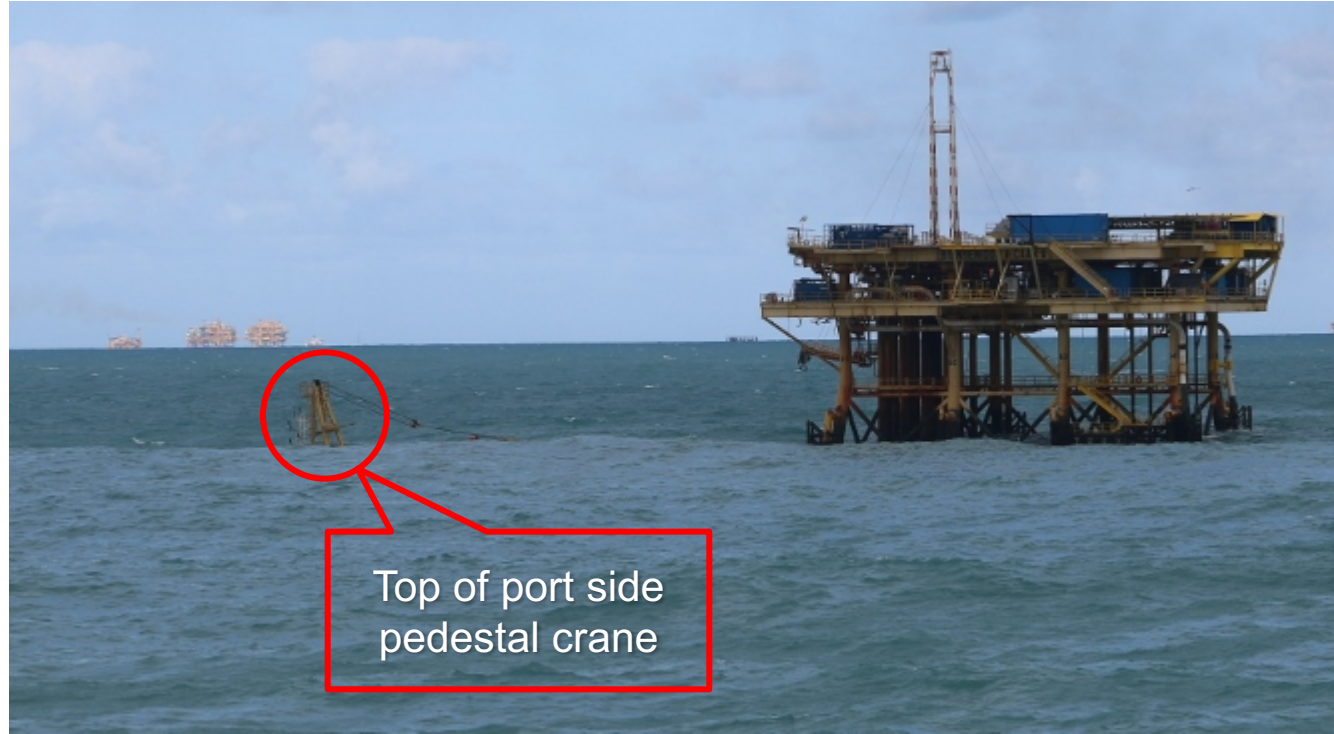
Troll Solution - Sunk 26 October 2015

Position after sinking

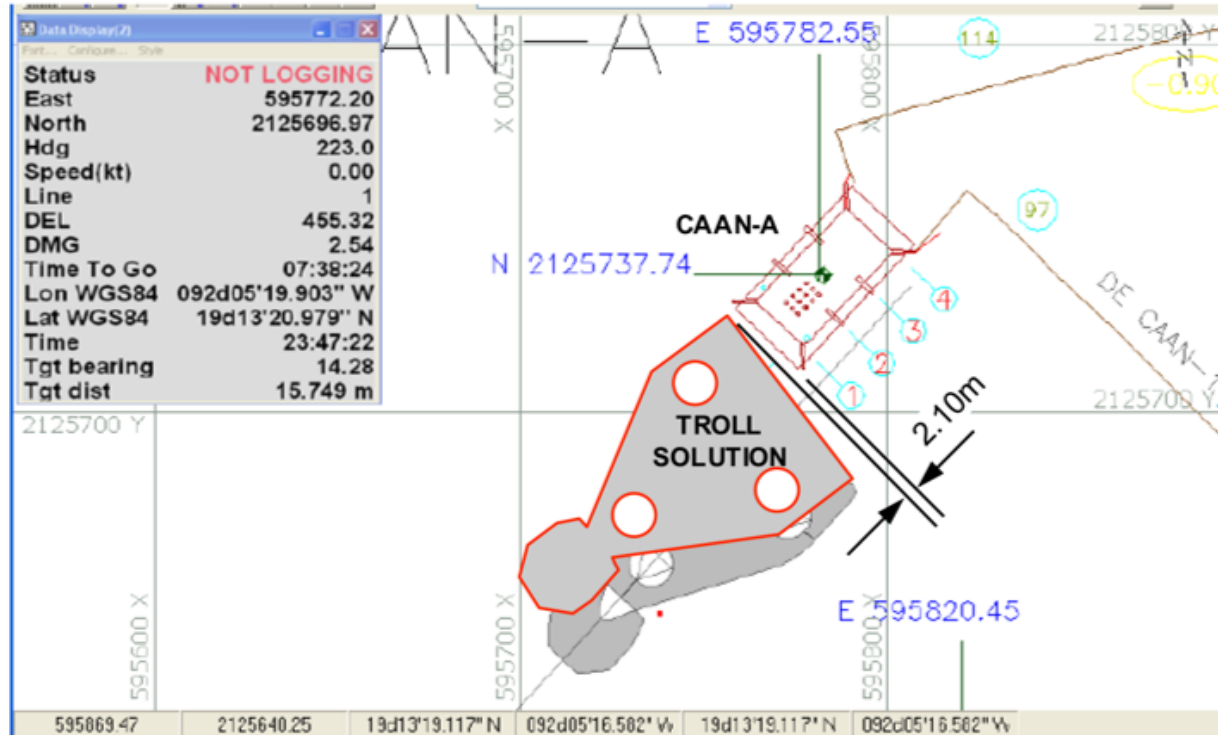
Troll Solution - Sunk 26 October 2015.

Condition of the wreck

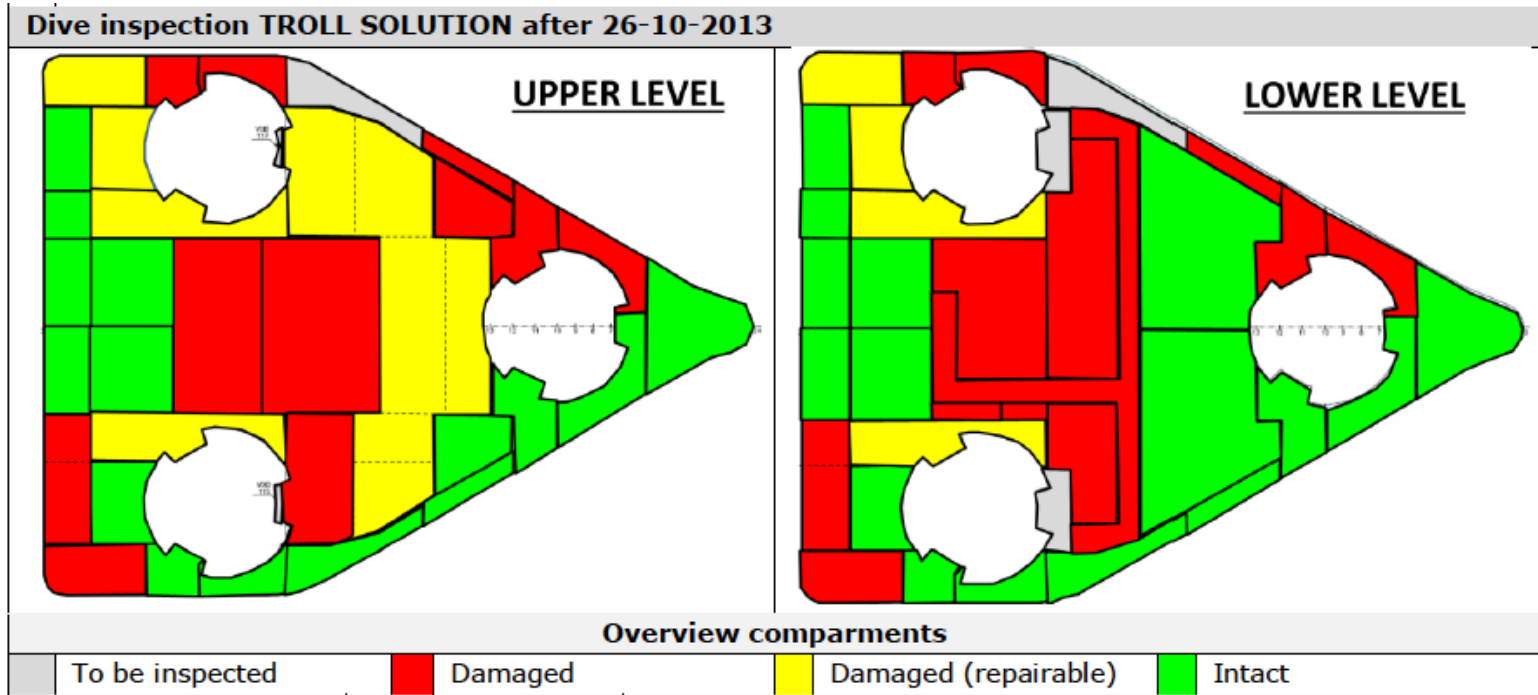
Troll Solution – Wreck Stability
